HISTORY OF GEAR FAILURES IN A STEAM TURBINE DRIVEN INTEGRALLY GEARED COMPRESSOR

MATTHEW BARAUSKY & PATRICK SMITH

42nd Turbomachinery
29th Pump SYMPOSIA

AIR
PRODUCTS

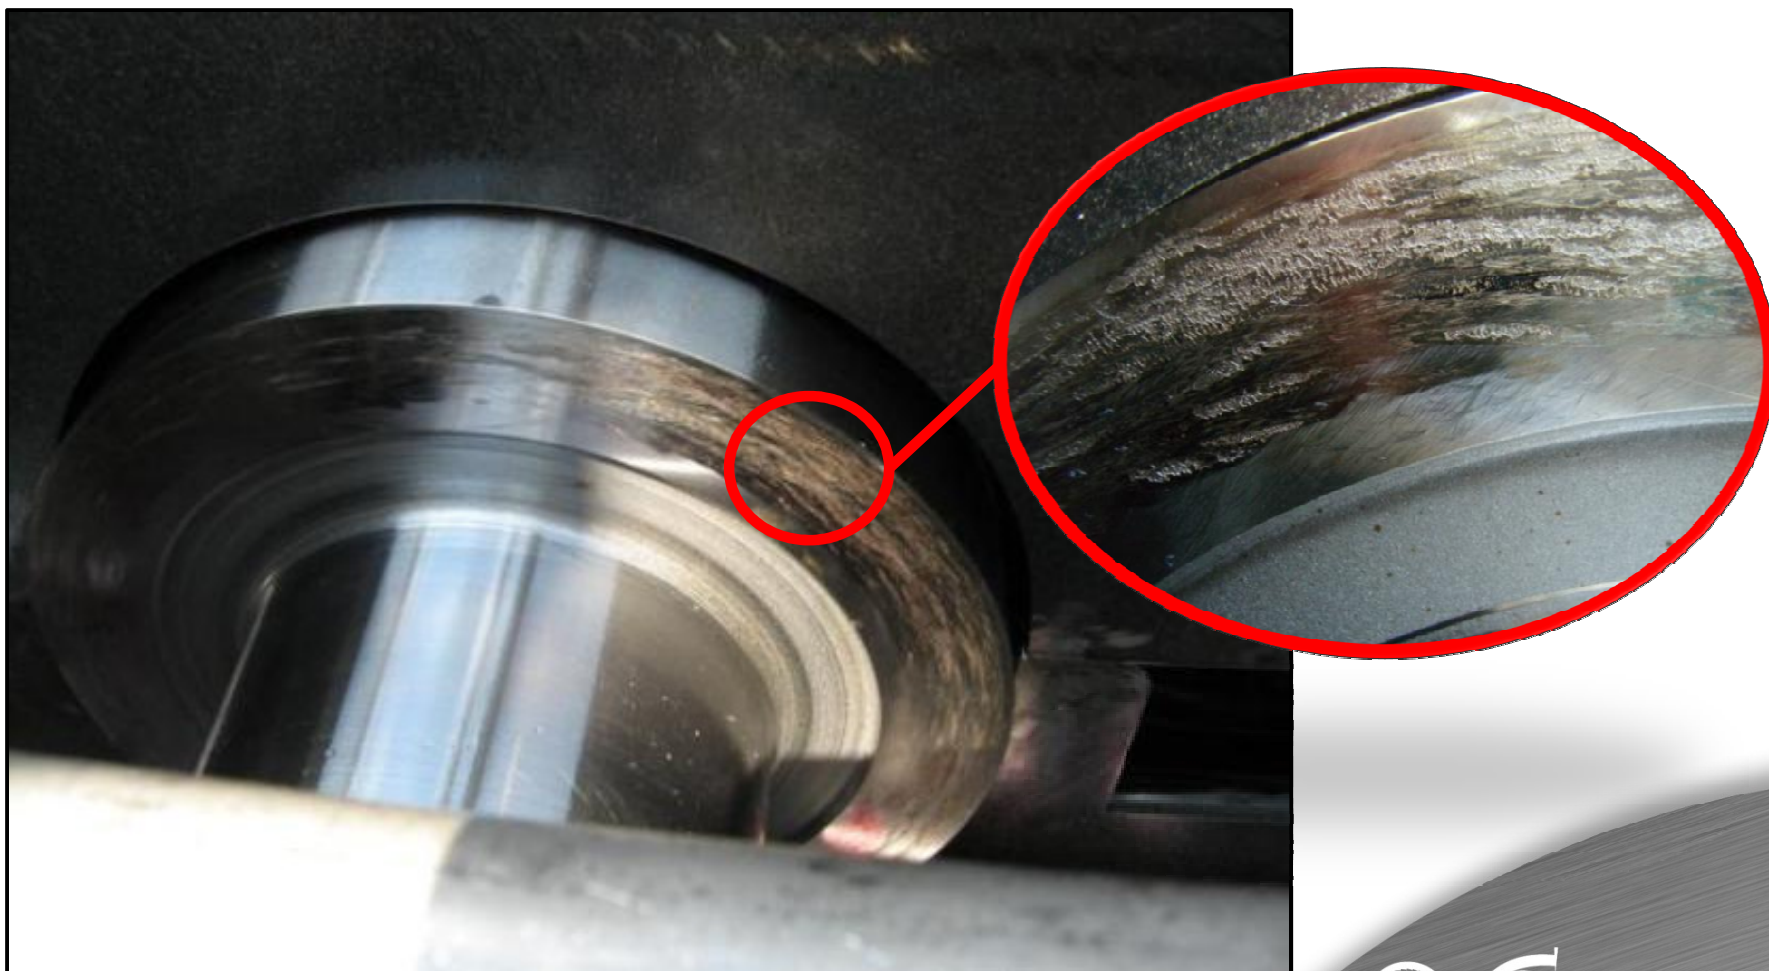
Thrust Collar Wear

- Found in routine gear inspection in May 2008.
- Determined wear was caused by insufficient oil pressure on emergency shutdowns when the AOP was delayed in starting.
- Significant thrust collar loading on an uncontrolled shutdown
- Corrective action was to address issues with the back-up generator and to institute routine gear inspections to monitor any progression of the damage.
- Thrust collars have been inspected several times since May 2008 with no change in the surface damage.

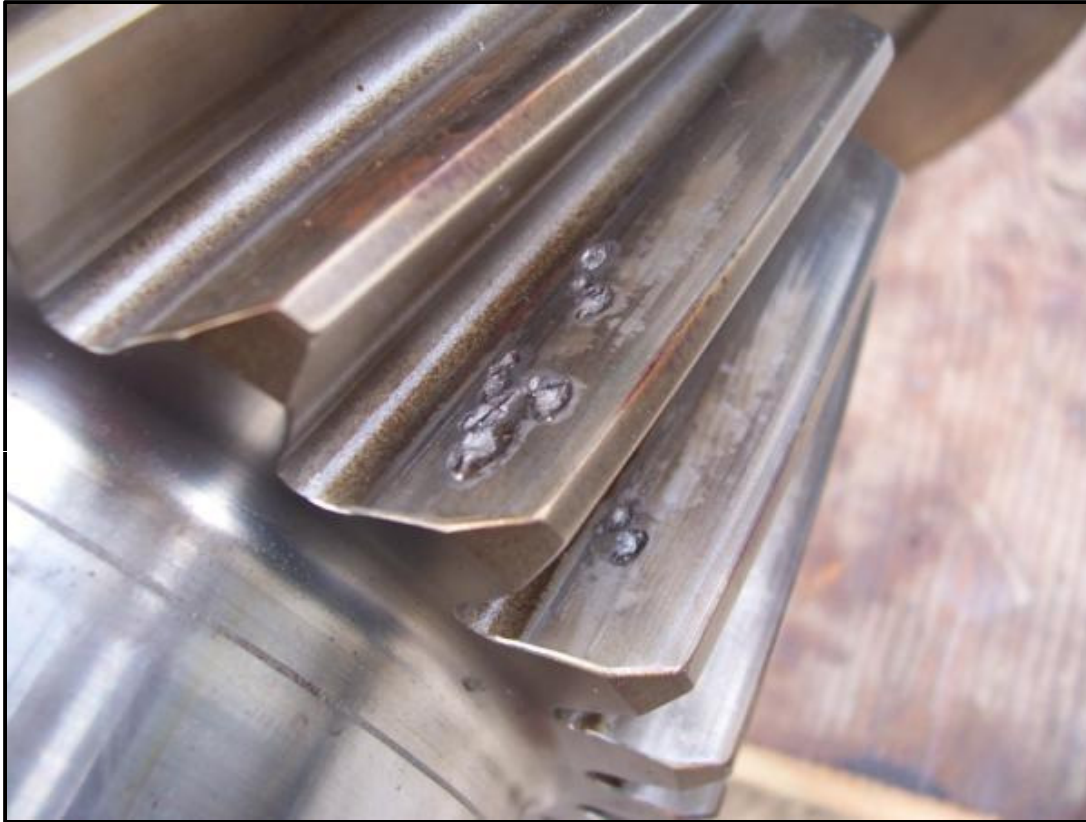
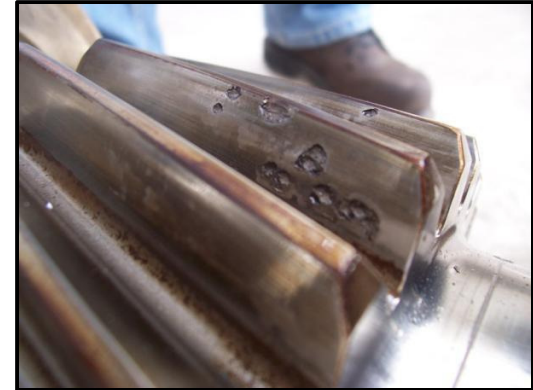
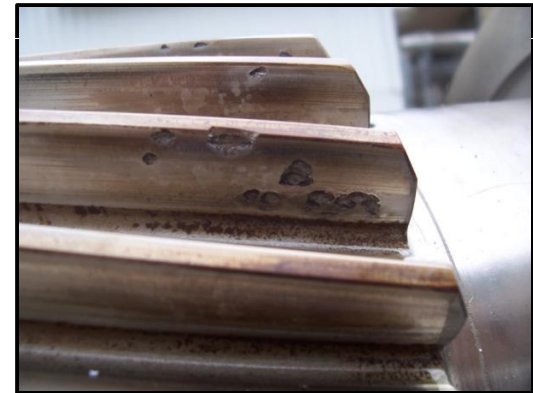
#1 Pinion Gear Teeth Pitting

- Large macropits on multiple teeth, no clear damage pattern.
- Gray staining on teeth adjacent to pitting damage.
- Some pits appeared to initiate sub-surface and had a fish eye type appearance which is indicative of hydrogen contamination.
- Tested chemical and mechanical properties were acceptable.
- Oil analysis revealed that the oil additives were being depleted.
- Original oil contained zinc as part of additive package which was not recommended by the gear manufacturer.
- Gearing was highly loaded.
- Pinion was end loaded.

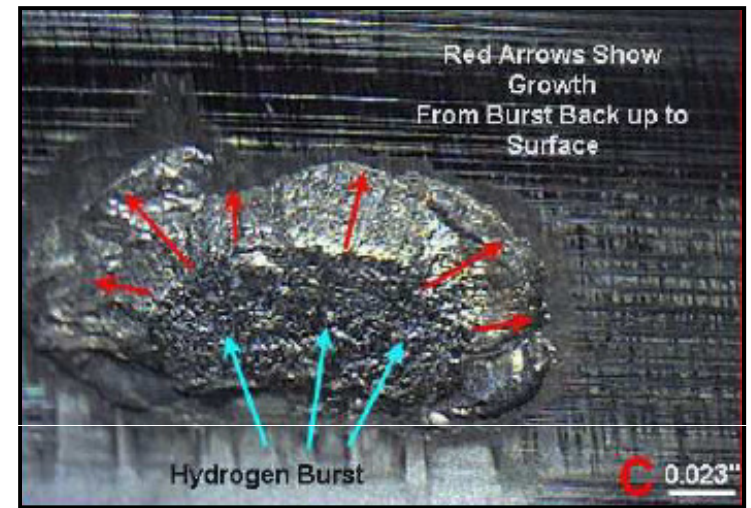
#1 Pinion – H₂ Contamination

- Several pits had a fish eye appearance which is indicative of excessive H₂ that was trapped in the material.
- Damage initiated below the surface at internal bursts. Semi-circular, shiny in the center and rough along the edges.
- Material testing did not find excessive trapped hydrogen (<1.5 ppm).
- Corrective action:
 - Control H₂ to 2 ppm maximum.
 - Perform hot top testing during steel processing of new gear.

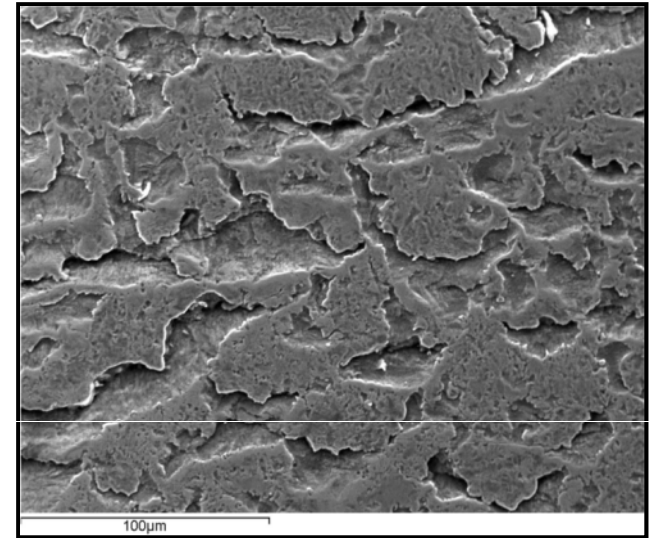
#1 Pinion - Lubricant Failure

- Key oil requirements:
 - ISO VG32 / FZG ≥ 8.0
 - No zinc in additive package
- Actual oil:
 - ISO VG32 / FZG = 8.0
 - Contains zinc in additive package
- Gray staining appears to be micropitting which is strongly influenced by the chemical composition of the lubricant.
- Oil analysis indicates oil is breaking down
- Correction Action:
 - Investigating a lubricant upgrade
 - Upgrading oil analysis requirements

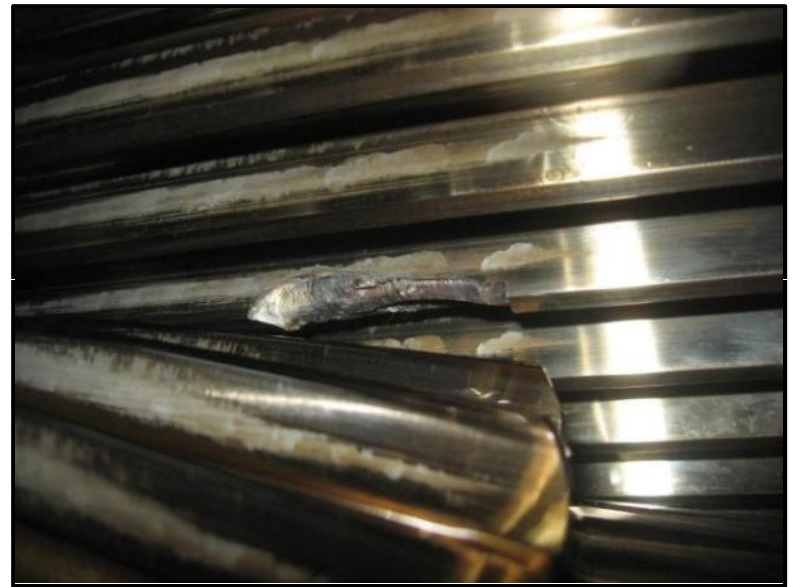
Broken Bullgear Tooth

- Small pit observed on bullgear tooth in January 2012. Pit was dressed out; NDT did not reveal any crack indications
- Oil pump gearing failed in late October 2012. Compressor shutdown on high vibration.
- Broken bullgear tooth observed.
- Tooth was dressed out and NDT did not reveal any crack indications. Compressor was restarted. New bullgear placed on order.
- Inspected in January 2013 no progressive damage observed.

- Bullgear teeth show evidence of gray staining which is indicative of micropitting.
- Likely caused by same mechanism that caused macropitting damage in #1 pinion.
- Metallurgical analysis planned for bullgear after it is replaced
- No additional corrective action other than what is already planned
